1.0 Bluewater, New Mexico, Disposal Site

1.1 Compliance Summary

The Bluewater, New Mexico, Uranium Mill Tailings Radiation Control Act (UMTRCA) Title II Disposal Site was inspected on August 29, 2007, and was in excellent condition. Overall, the disposal cells and their cover materials are in excellent condition; however, several shallow depressions exist on the cover along the north edge of the main tailings disposal cell, and they will be surveyed in 2008 to determine if repairs are necessary. Maintenance work conducted at the site in 2007 included repair of the asbestos disposal cell cover, repairs to eroded sections of the site perimeter road, removal of windblown sand from the fences at the site entrance, and fence repairs. These repairs were in good condition at the time of the 2007 inspection. Groundwater monitoring results indicate that all compliance requirements continue to be met. No cause for a follow-up inspection was identified.

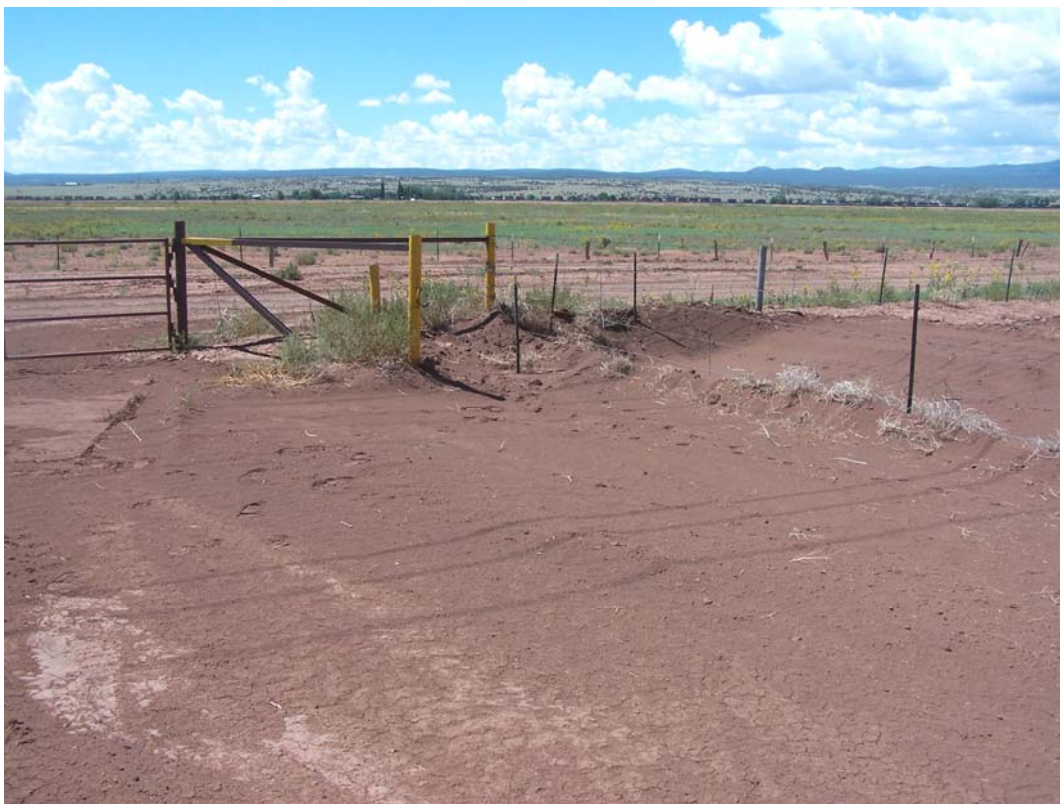
Entrance Gate, Access Road, Site Access Gate, and Signs—Access to the site is directly off of Cibola County Road 334; no private property is crossed to gain site access. The entrance gate (at County Road 334) is a steel, double-swing stock gate. The gate is secured by a chain and locks belonging to DOE and the various utility companies that have rights-of-way across the site. The access road leads from the entrance gate to the main site access gate that also is a steel, double-swing stock gate secured by locks. The access road is an all-weather road surfaced with crushed basalt and extends northward along a narrow strip of DOE property for approximately 1,700 feet from the entrance gate to the main site access gate. The entrance gate, access road, and access gate were all in good condition. Windblown sand tends to accumulate near the entrance gate and
1A had buried the boundary monuments and portions of the perimeter fence. The sand was moved away from these locations a week prior to the inspection (PL–1).

BLU 8/2007. PL-1. Windblown sand removed from the west fence near boundary monument BM-21 to the site entrance.

During 2007, the asbestos cell cover, perimeter fence, and the perimeter roads were repaired. Also, windblown sand was removed from the fence near the site entrance gate. The site was checked on a monthly basis by a local subcontractor for evidence of trespassing and to ensure that the perimeter fence is intact.

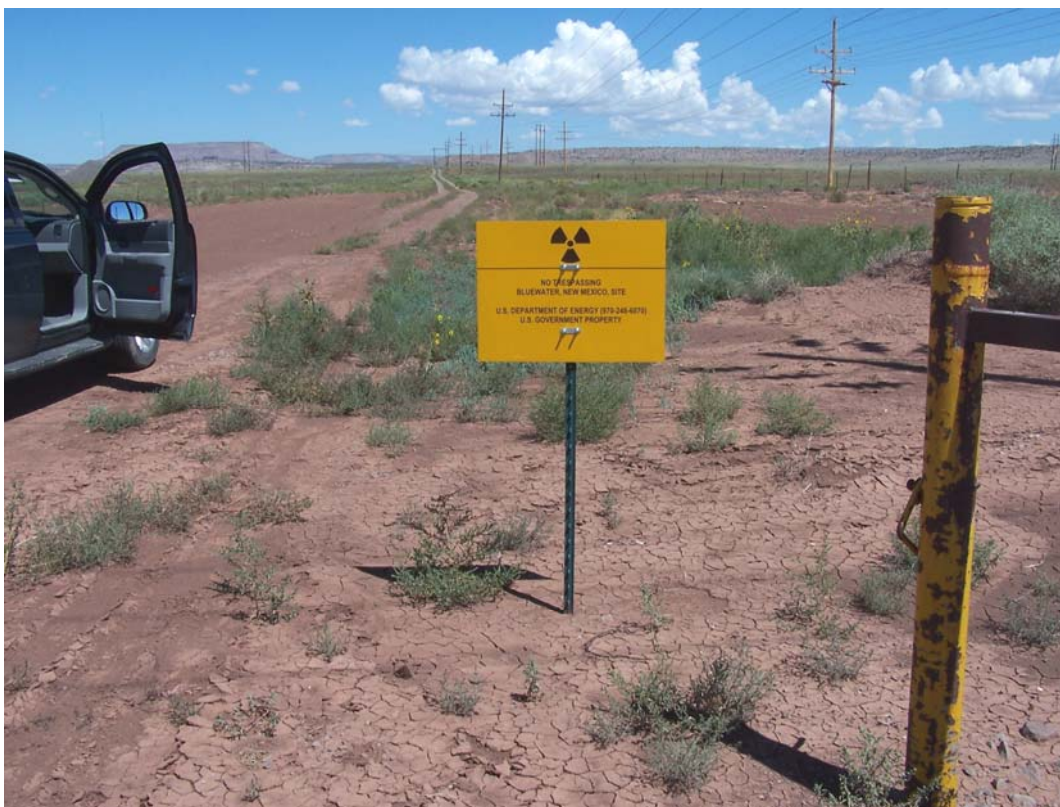
Fifty-five warning signs, designated as perimeter signs P1 through P52 on the drawings (including perimeter signs P2A, P9A, and P9B), are mounted on steel posts at access points along right-of-way intersections within the site boundary and around the main and carbonate
1B tailings disposal cells. Perimeter sign P1, located at the site entrance, was missing from the entrance gate and a new sign was installed on a metal t-post inside the gate (PL–2). Perimeter sign P3, damaged by a shotgun blast, is still legible. All other signs were in good condition.

BLU 8/2007. PL-2. New perimeter sign P1 located inside the entrance gate.

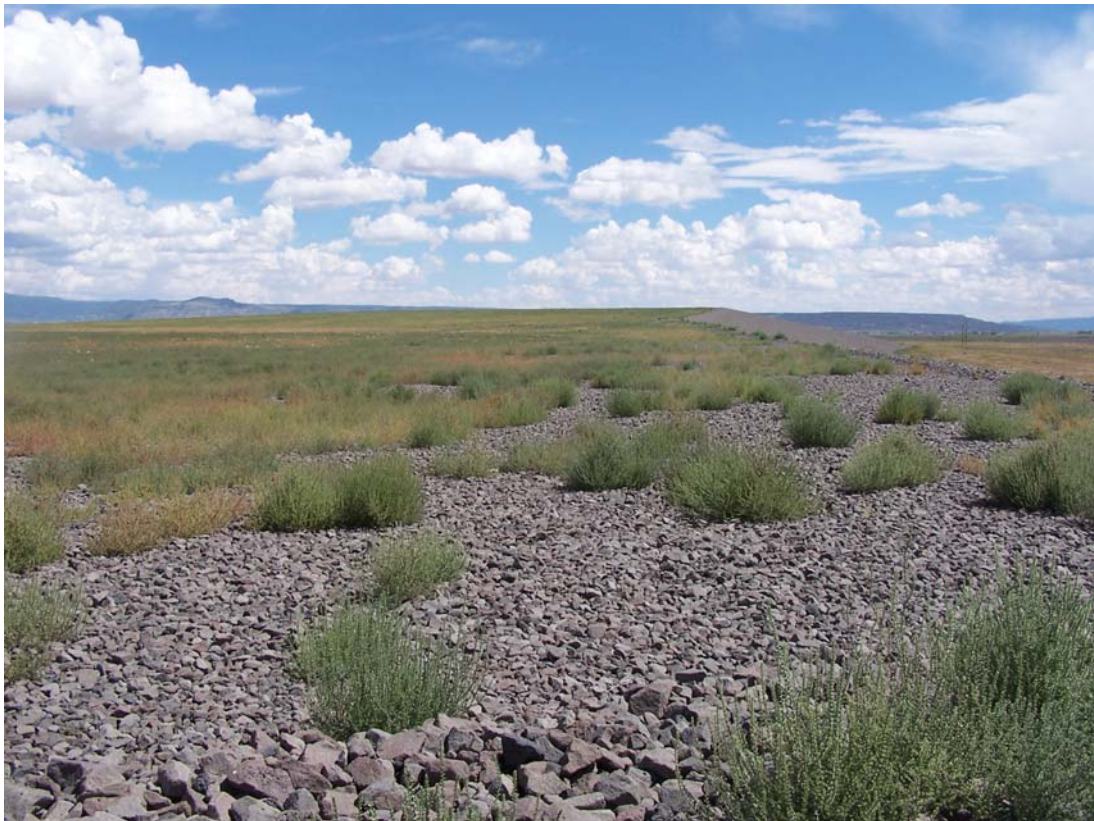
As shown on photo PL-4, the top of the main tailings disposal cell had an extensive cover of annual weeds (primarily Russian thistle, which is not a listed noxious weed in New Mexico), along with some wildflowers and deep-rooted shrubs (rabbitbrush and four-wing saltbush). Patches of annual weeds also were present on the east side slope of the cell. Control of plant encroachment is not required by the LTSP.

BLU 8/2007. PL-4. The southwest edge of the main tailings disposal cell cover.

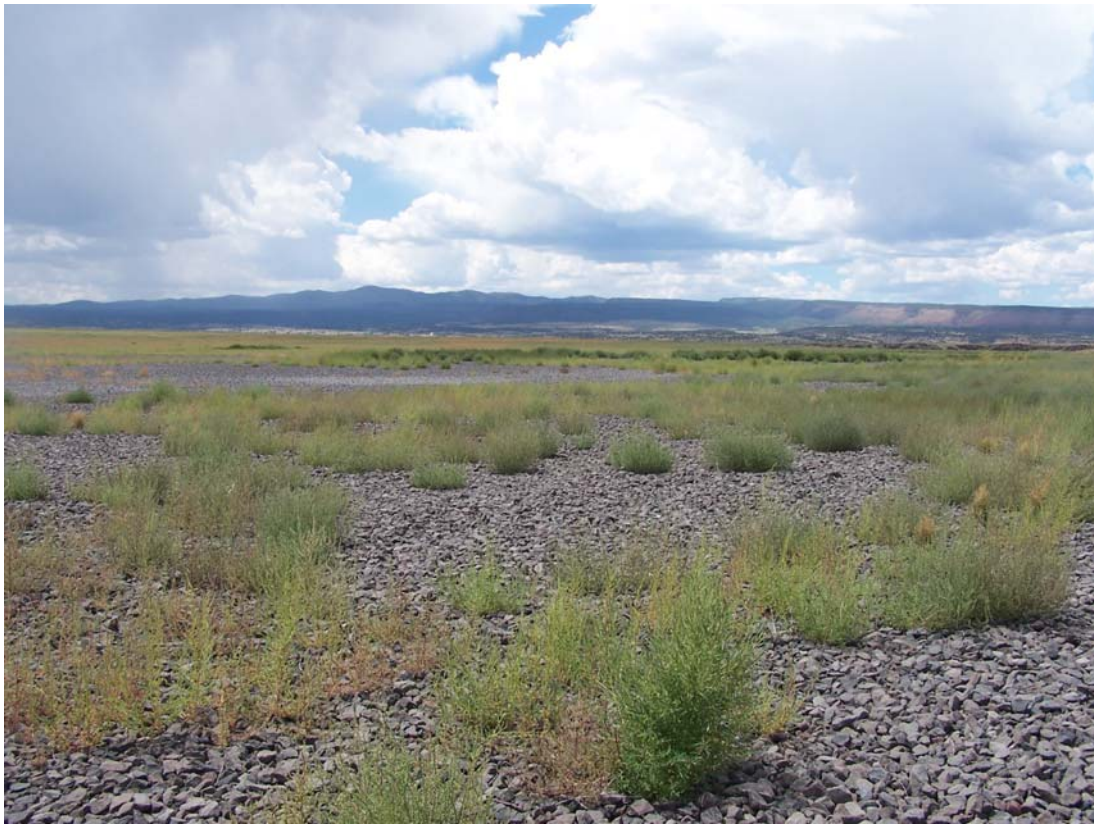
Several small shallow depressions exist on the relatively flat north end of the top slope of the main tailings disposal cell (PL-5). Although ponded water has been observed in the past, the depressions have been dry during the last several inspections. Given that evaporation greatly exceeds precipitation in this area, ponding is believed to be infrequent and brief and, therefore, is not considered to be a concern at this time. Slimes from the settling ponds were placed in the northern part of the main tailings disposal cell, and areas containing slimes are more likely to settle than areas containing drier waste materials. The depressions will continue to be monitored for evidence of significant settling or displacement. A survey of the affected area is planned for 2008 to compare the current surface configuration with the design drawings, and the results will be evaluated to determine if repairs to the cover should be considered.

BLU 8/2007. PL-5. Depressions along the north edge of the main tailings disposal cell.

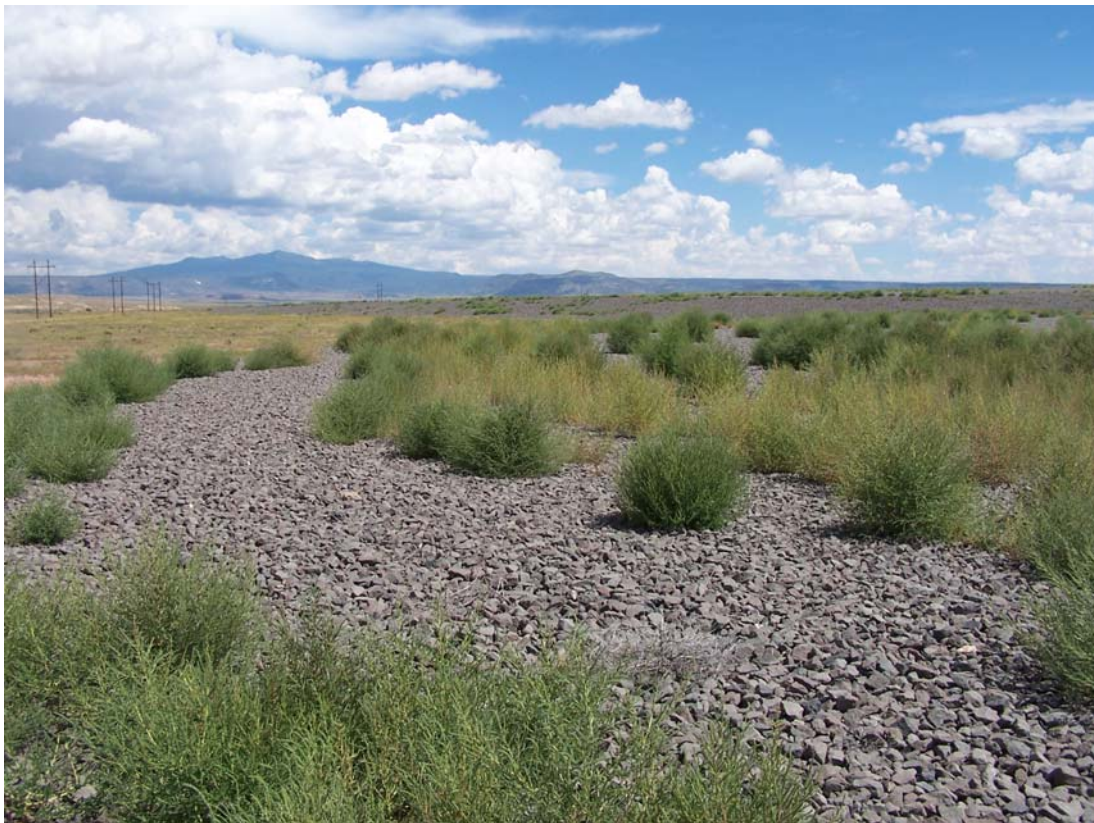
Carbonate Tailings Disposal Cell, Asbestos and PCB Disposal Areas, and Landfills—The top and side slopes of the carbonate tailings disposal cell are covered by basalt riprap. The top, for the most part, slopes gently eastward. The small northwest and southeast extensions slope in their respective directions. Annual weeds and scattered woody shrubs were present on the cell and its extensions (PL-6). The carbonate tailings disposal cell was in excellent condition.

BLU 8/2007. PL-6. View across the northwest extension of the carbonate tailings disposal cell.

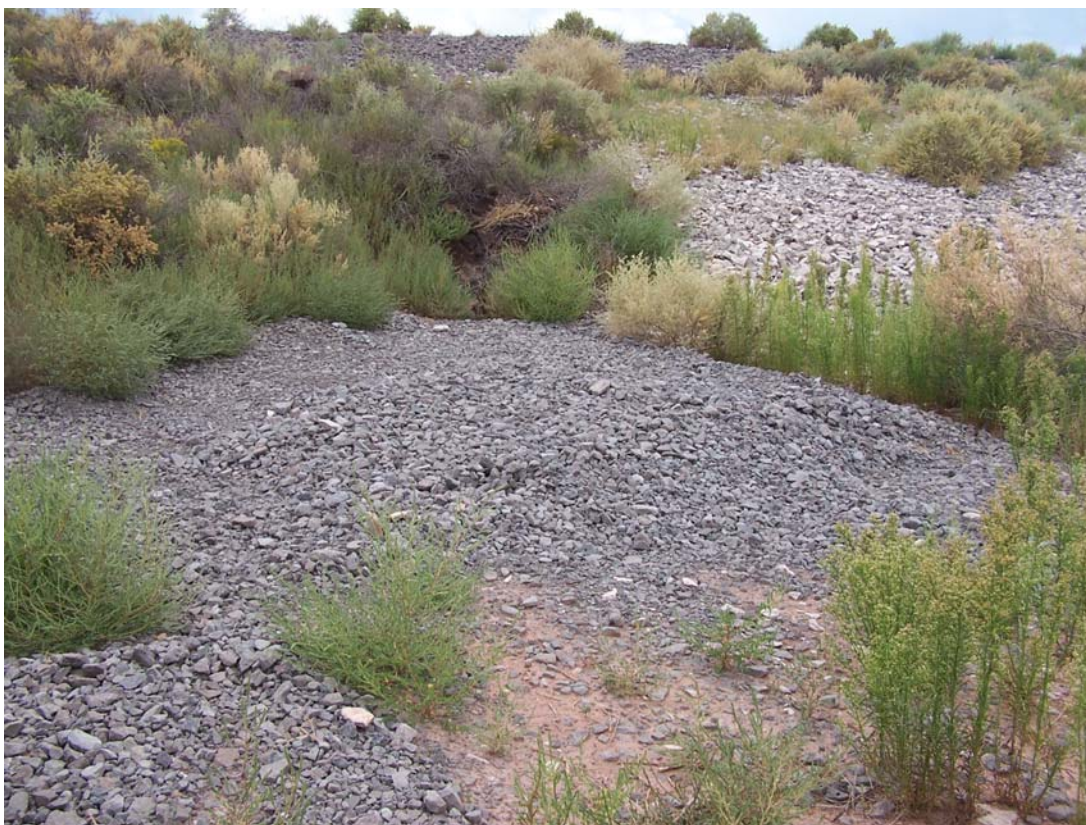
The asbestos disposal area is a bowl-like feature just south of the carbonate pile. The north, west, and south side slopes of this feature are covered by limestone riprap; the bottom of the bowl (the asbestos cell cover) is grass covered. A small depression was located along the south edge of the disposal area. The depression, probably the result of piping or collapse of uncontaminated fill material incompletely compacted during final grading, was first noted during the 1999 annual

1C inspection but had not been a concern because it does not encroach on asbestos-containing materials. However, to mitigate the potential for encroachment into these materials, the depression was filled with crushed basalt rock during spring 2007. No additional settling had occurred since the repair was completed (PL-7). The asbestos disposal area is in excellent condition.

BLU 8/2007. PL-7. Repaired depression in the asbestos disposal cell cover.

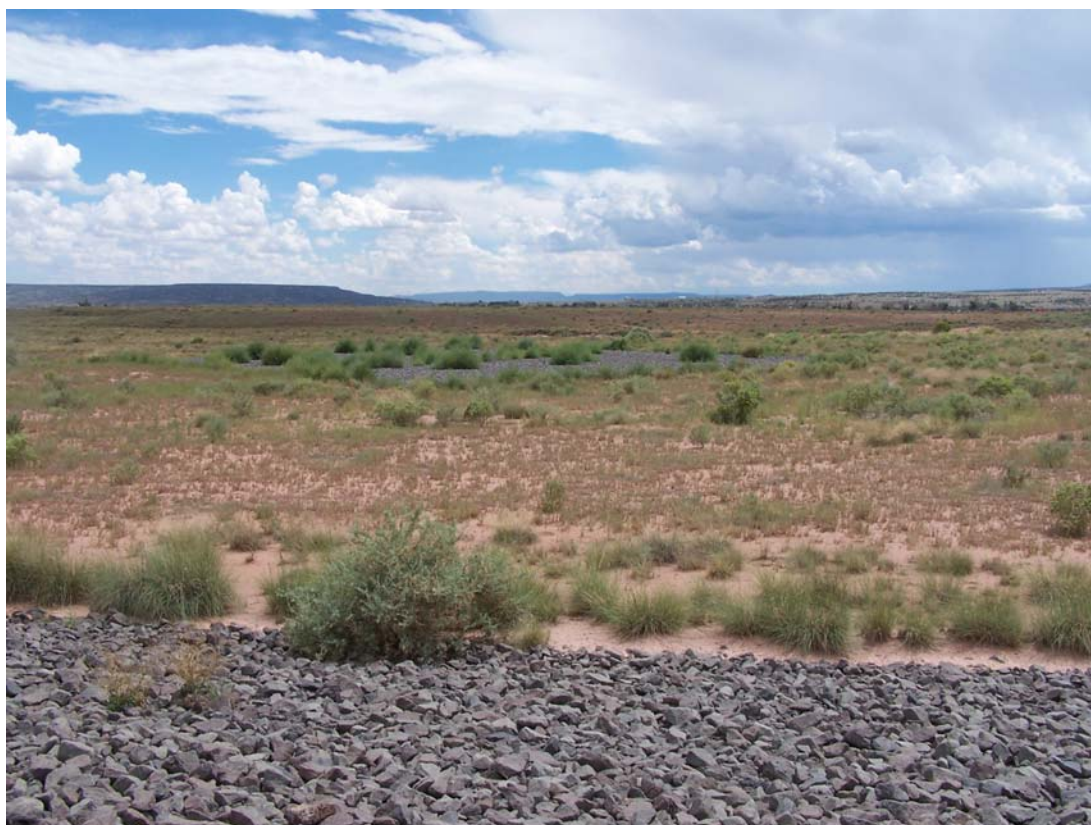
The small riprap-covered PCB disposal area is in excellent condition (PL-8). The two grass-covered landfill areas east of the carbonate tailings disposal cell also are in excellent condition. Two other disposal areas, Disposal Area Number 1 and the Stockpile Area, are south of the carbonate tailings disposal cell. Both are grass-covered and in excellent condition.

BLU 8/2007. PL-8. The PCB disposal area cover.
